## MEMORANDUM

Date: June 25, 2020

File No.: 05.0046650.02

Re: Geohydrologic Review

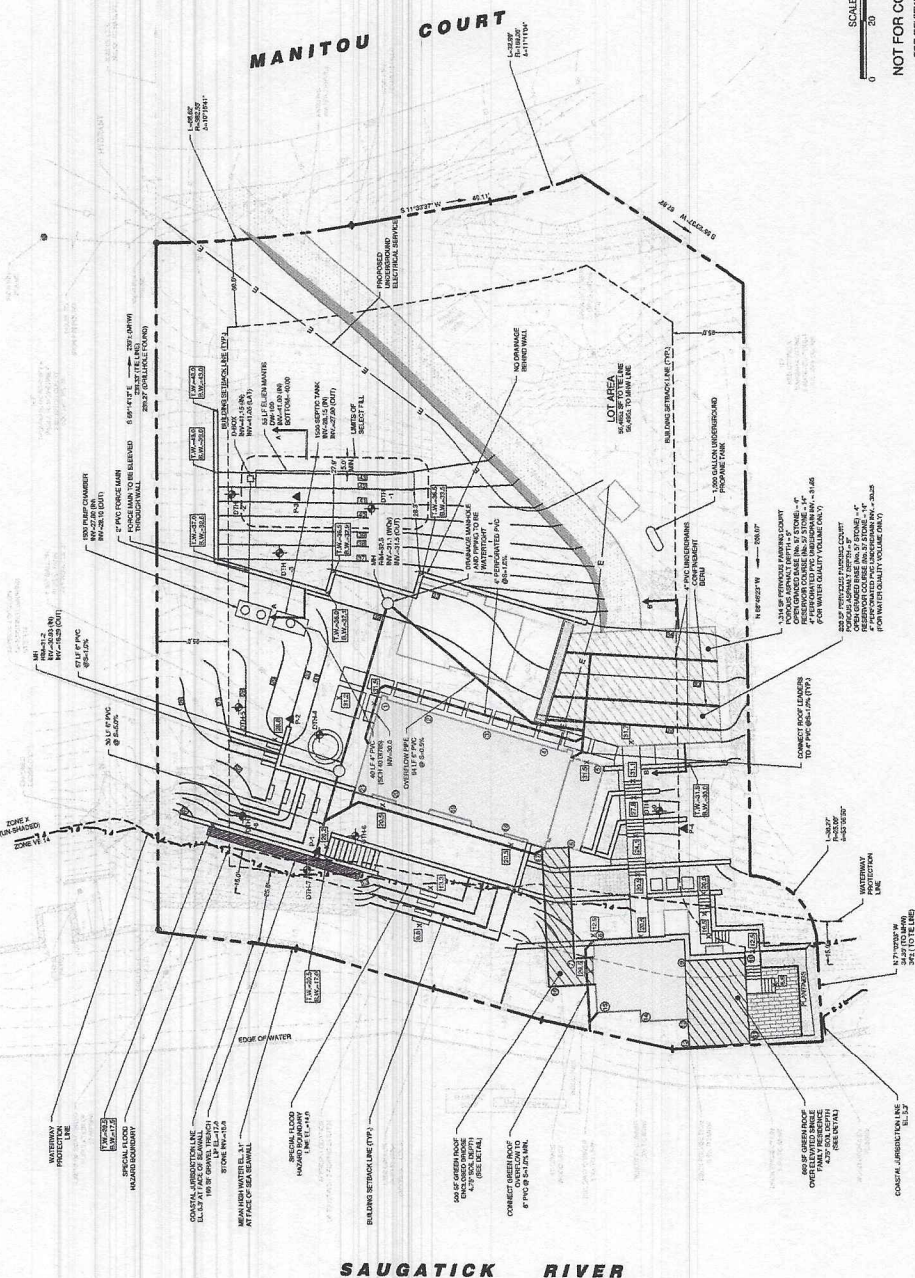
Figure C-2

Some of the stormwater runoff will be directed to a 165 sf Gravel Trench located in the northwest portion of the Site. We understand the system is designed to infiltrate the design storm (i.e., 1-inch rainfall event) into the groundwater table. Larger design storms overflow the top of the Gravel Trench. The top of the Gravel Trench will be at elevation 17 feet and the bottom of the stone in the trench will be at elevation 15 feet. There is a 2 to 1 slope on the downgradient side of the Gravel Trench and at the base of the slope is a 1 to 2-foot-high stone retaining wall. A flat slope then extends 7 to 12 feet westward to the seawall. Refer to Figures 1 and C-2 for proposed conditions.

2. The area downgradient of the Gravel Trench (with 2 to 1 side slopes and a stone retaining wall at the base of the slope) should be designed to prevent surficial erosion or groundwater seeps. In addition, the southern portion of the Gravel Trench should be adjusted such that the top surface of the Gravel Trench (at elevation 17 feet) will be consistent with the proposed grades in that area, and will not cause seepage breakout at the abutting lawn steps (to the south).
